Conservation Guidance Note :

Thatching

Planning Services

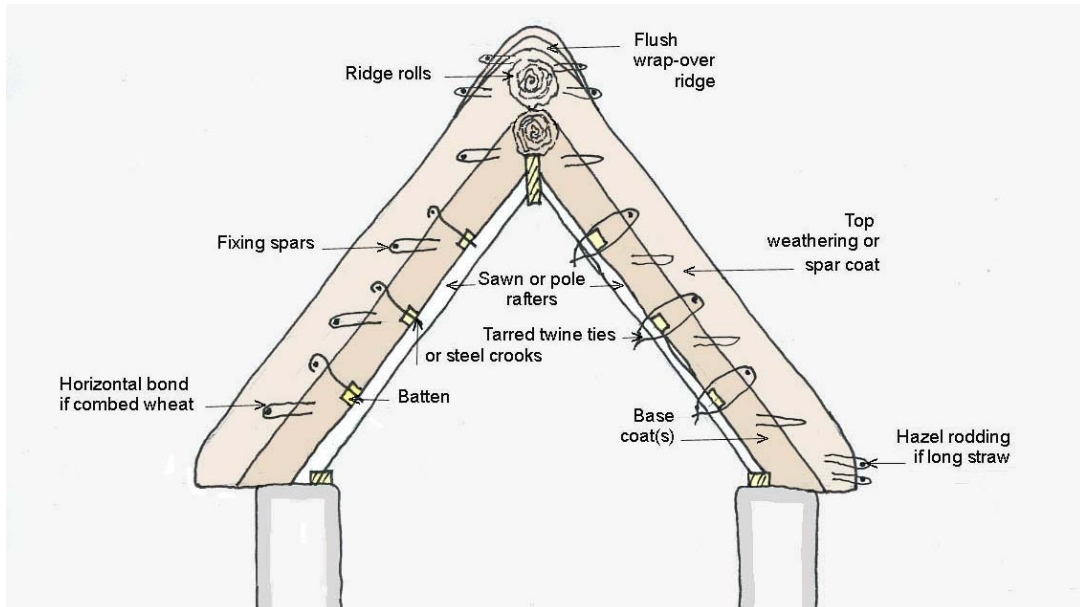
Diagram 1. Simplified cross-section through a typical thatched roof and ridge

Photo 4 - Close up of combed wheat being laid. The provision of a horizontal bond formed of hazel liggers (which will eventually be concealed – see Diagram 1) highlights a major difference to laying in the Long Straw style. It should be noted however that the bond in most historic buildings within the District is formed by tying a small portion of each bundle to its neighbour – a straw bond.

Block ridges are typical of East Anglian roofs and tend to look out of place in the Wiltshire landscape. All other things being equal, flush, wrap-over ridges (see *Diagram 1 and Photo 5*), sometimes called turn-over ridges, will prove to be the most aesthetically pleasing and more hard wearing. Butts-up ridges are more vulnerable to weathering but are sometimes justified if only one slope of the roof is being re-thatched. Accordingly the Council has adopted the following policy.

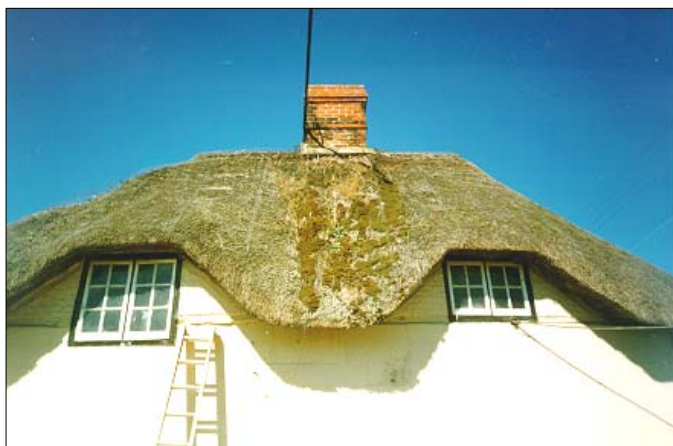
Photograph 1 – Time for action. Note the concave dip and fixing spars visible on the left hand hip, the stranded flashing around the chimney, and the heavy build up of moss indicating permanently damp areas.

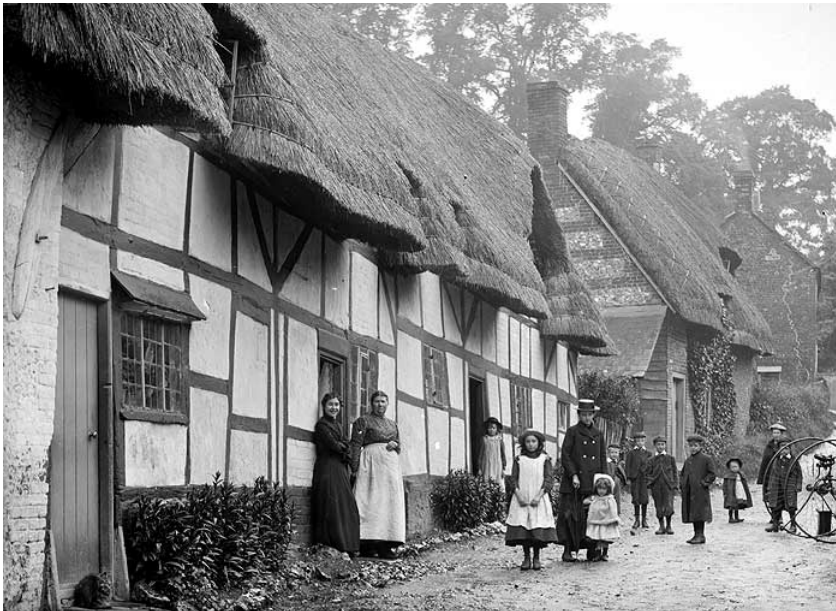
Photograph 2. Burdett Street, Ramsbury at the end of the 19th century.

Special care should be taken over the design of the ridge that covers the apex of the roof as it contributes greatly to the overall character. Early photographic evidence (such as *Photo 2* above) shows that cottage roofs in Kennet typically have minimal decorative work on the ridge.

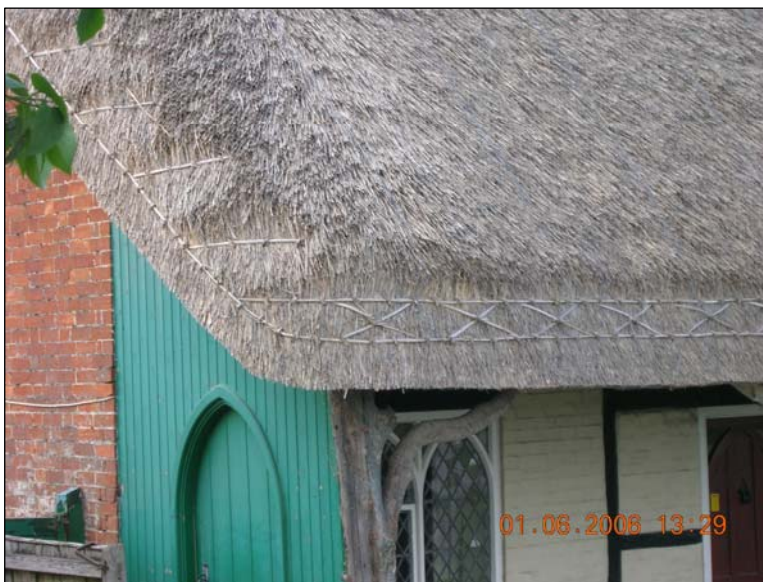
Photograph 3 - Close up of long straw thatch – note distinctive straps fixed at the eaves

This technique of thatching has a distinctive appearance with its surface having an open texture, and the length of the stem visible on the surface of the roof, rather than the overall length of the material, giving rise to the term. Classically, after delivery to the site, the loose material is shaken and dampened into a bed from which yealms are pulled into manageable amounts ready for laying on the roof. In this area however the thatcher rarely built a bed and no great effort is made to ensure a 50:50 mix of butts and ears. The laying of the straw with the majority of butts on the outer surface is normal practice in the district. The thatch is fixed with hazel spars and laid to an even plane without the need to dress or beat it into position. At close range the thatch appears to have been poured on, enabling it to follow any irregularities in the plane of the roof without giving rise to rupture or stress. Also the provision of horizontal rodding of *long straw* eaves and gables is a necessary feature in controlling the loose mixed ends of the straw.

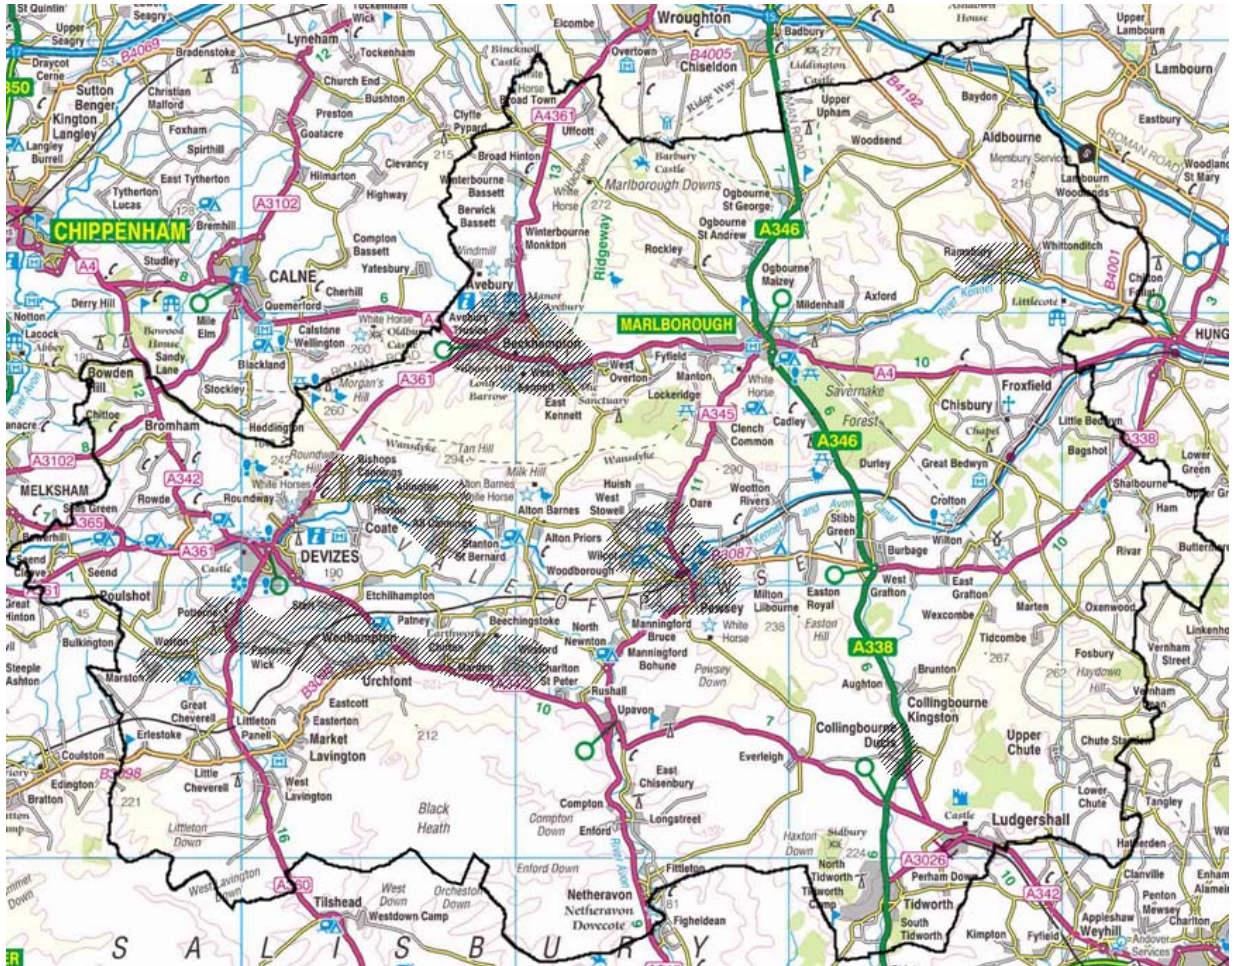
Map 1. The shaded areas indicate the concentration of long straw thatched roofs (2006)

Roofs thatched with *long straw* are still found throughout the district. A concentration in a number of parishes is however discernible. As explained below there was a diminution in the number of *long straw* roofs during the second half of the 20th century and this reduction has been most strongly felt in some of the eastern and southern parishes of the District. The concentrations however enable the detection of a number of long straw villages, most notably Urchfont, Wedhampton, Potterne, Marston, Bishop's and All Cannings, Pewsey and Wilsford.

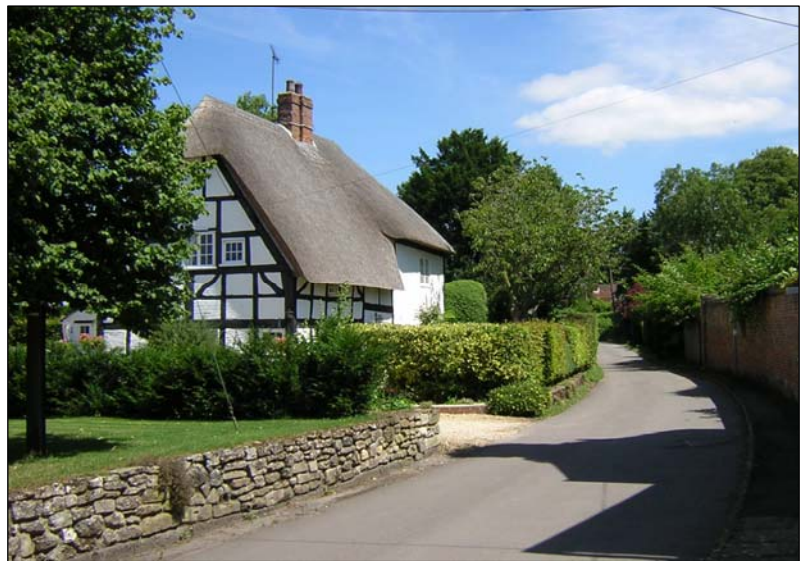
Photo 5 - a roof with a weathering coat of combed wheat – note the crisper lines and denser appearance of the thatch

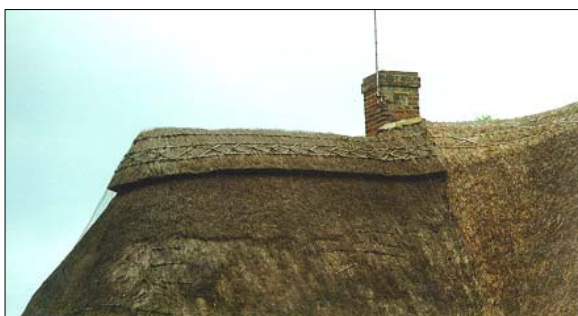
Photograph 6 - A block cut ridge

Simple straw flush ridges are usually much more satisfactory than deep block-cut ridges which are more expensive and technically inferior. Block ridges also require extra fixings and surface strapping and produce a drip line.

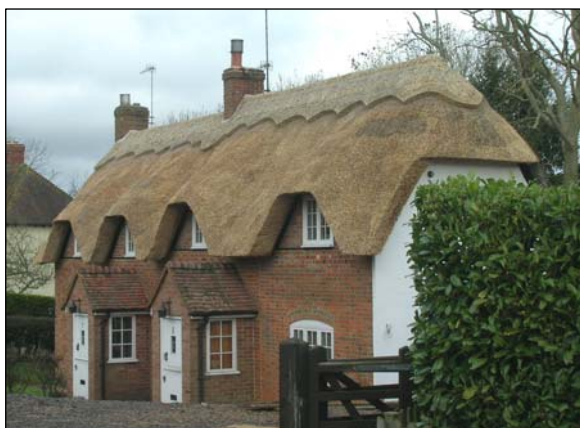
Photograph 7 - decorative block ridge

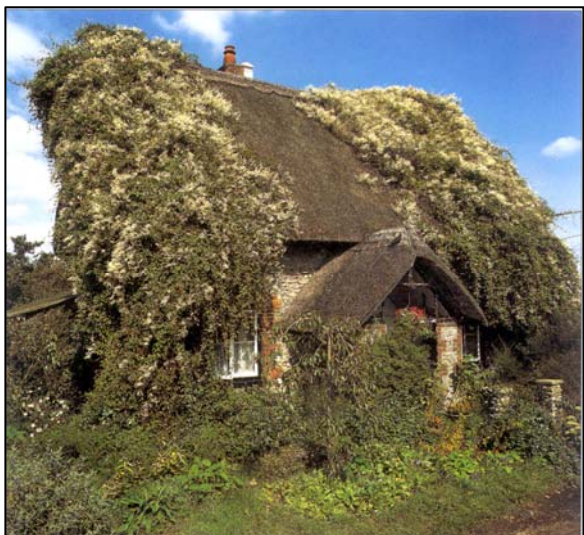
Photograph 8 – climbing plants need to be kept under control

Once re-thatching is completed, routine maintenance can help extend the lifetime of new thatch and particular attention should be given to occasional upkeep around any valleys and to the ridge. Look out for corroded wire netting and birds or vermin nesting in the roof, and climbing plants. These items should be inspected every year with an anticipated need for remedial works every ten years or so. If the netting is required to be temporarily lifted, the opportunity can be taken to gently clean off any build-up of thick mosses. In addition, external factors such as overhanging trees may need attention occasionally. The longevity of thatch can also be prolonged if all access onto the roof, for such items as fixing of tv aerials and soil vent pipes, is very carefully managed. Care should also be taken to ensure that any plastic coated wiring in the loft space is protected in a rodent resistant conduit to avoid the risk of shorting.

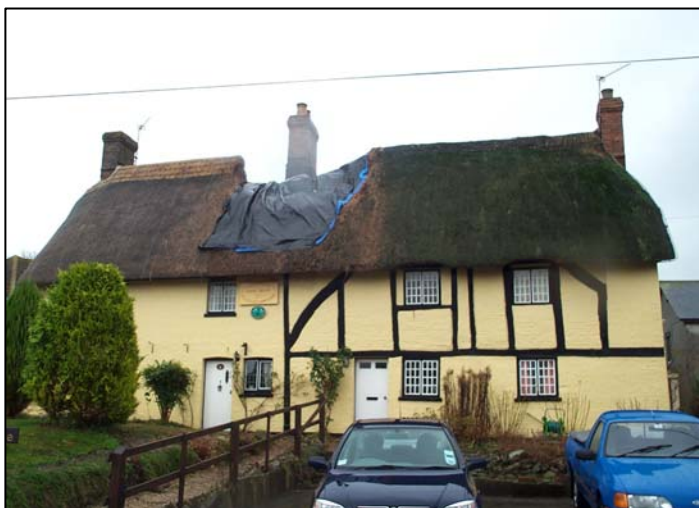
Photograph 9 – damage apparently caused due to an imperfect chimney

Although comparatively rare, fire represents one of the greatest threats to the conservation of an historic thatched roof. Even chimneys which appear to be in good order may have defective pointing or cracks below the ridge which allow hot gases to escape from the flue into the thatch. The leakage of hot gases creates hot zones which in time may combust and cause a thatch fire.

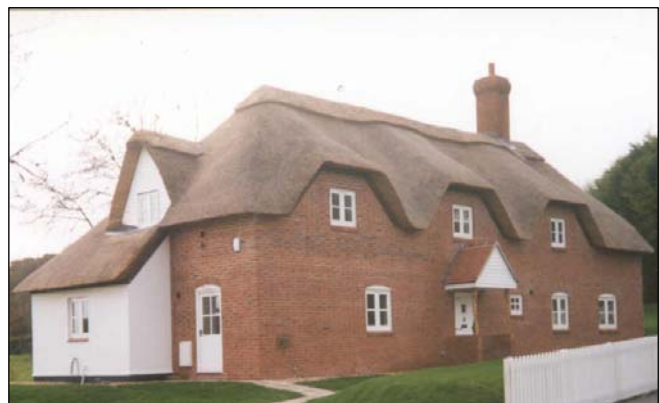
Photograph 11. Uncharacteristic features :

- ***abnormally tall chimney***
- ***dominant block ridge***
- ***gable dormer on hip end***
- ***brickwork over and around dormer windows***
- ***a high proportion of the roof lying at a shallow pitch.***

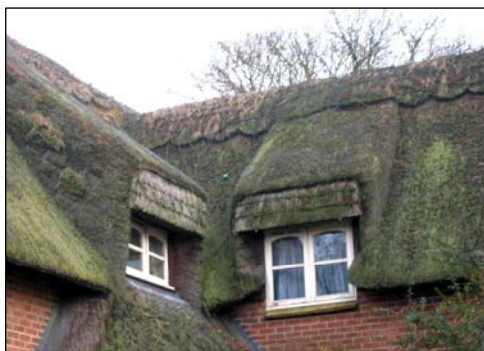
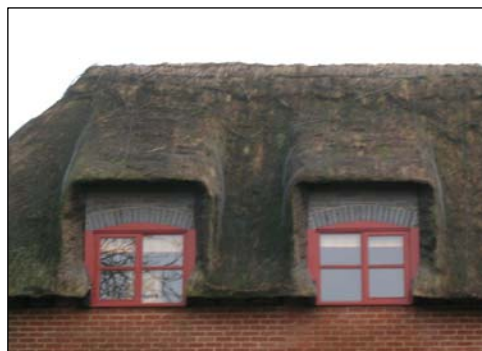
Photographs 12 and 13. Narrow valleys, higher thatch draining onto lower thatch, anomalous vertical thatch panels over and on the cheeks of tall eye brow windows.
