Conservation Guidance Note : **Thatching**

Planning Services

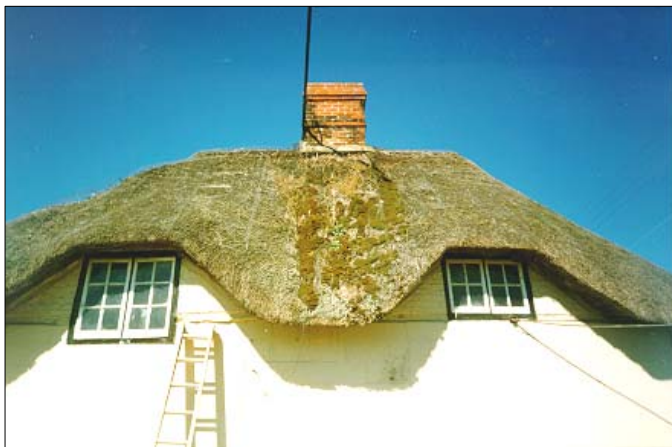
Photograph 1 – Time for action. Note the concave dip and fixing spars visible on the left hand hip, the stranded flashing around the chimney, and the heavy build up of moss indicating permanently damp areas.

Ideally, the plane of a roof will weather-back slowly and evenly. The time for re-thatching can be ascertained when the knuckles of the hazel spars that fix the top straw coat become apparent uniformly over the whole roof. The rate of weathering, however, will not always be consistent so there is a need to watch out for depressions, vertical lines or slippage in the thatch. Dark stains on the underside of the eaves may indicate how far rain is penetrating into the coats. Patches of moss and fungus may also indicate permanently damp areas, although the growth of certain lichens can act as a beneficial binder as the thatch gets older.

The critical thing is to ensure that re-thatching should take place before rain penetrates into the base coats.

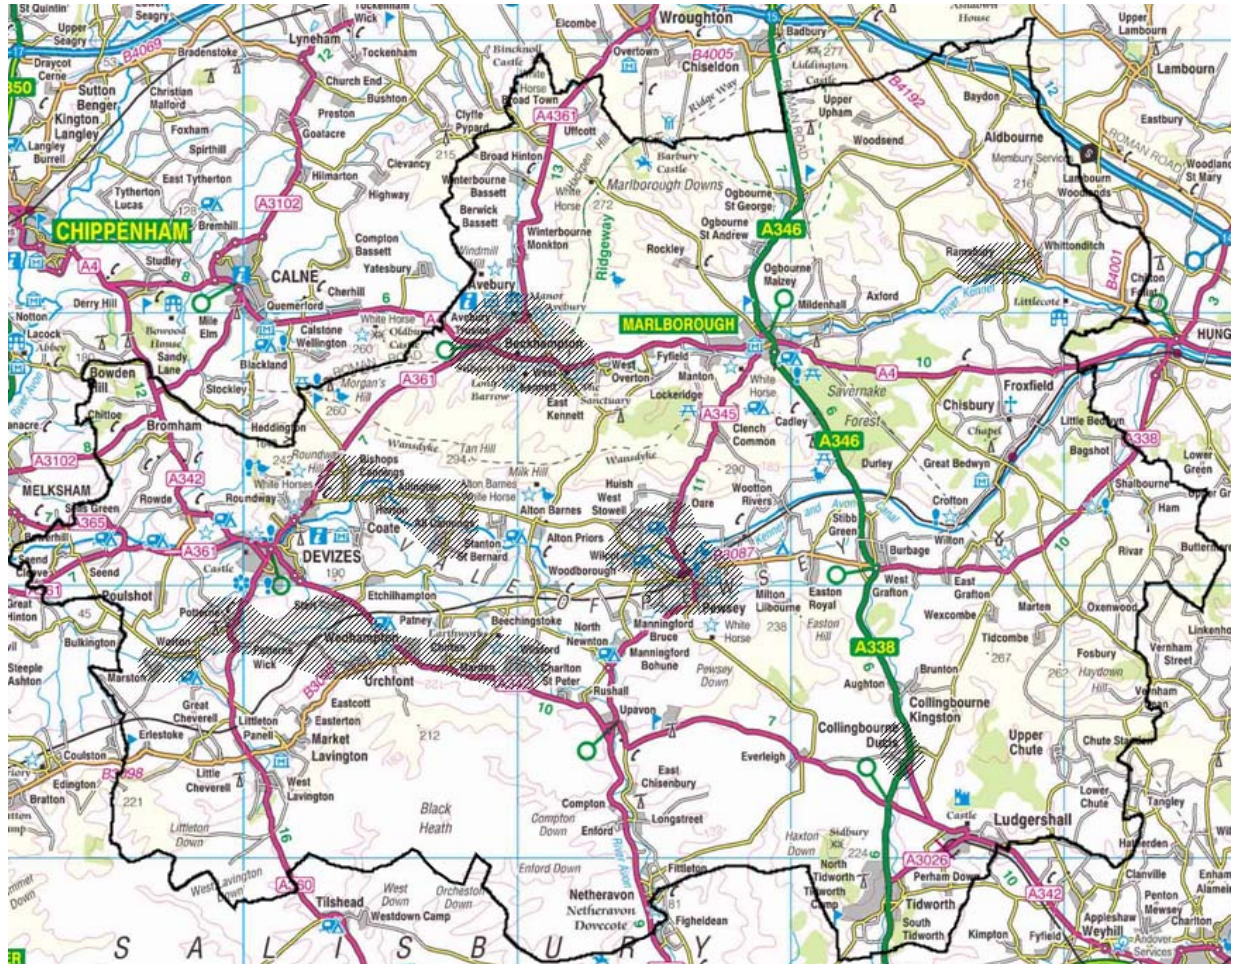
Map 1. The shaded areas indicate the concentration of long straw thatched roofs (2006)

Roofs thatched with *long straw* are still found throughout the district. A concentration in a number of parishes is however discernible. As explained below there was a diminution in the number of *long straw* roofs during the second half of the 20th century and this reduction has been most strongly felt in some of the eastern and southern parishes of the District. The concentrations however enable the detection of a number of long straw villages, most notably Urchfont, Wedhampton, Potterne, Marston, Bishop's and All Cannings, Pewsey and Wilsford.

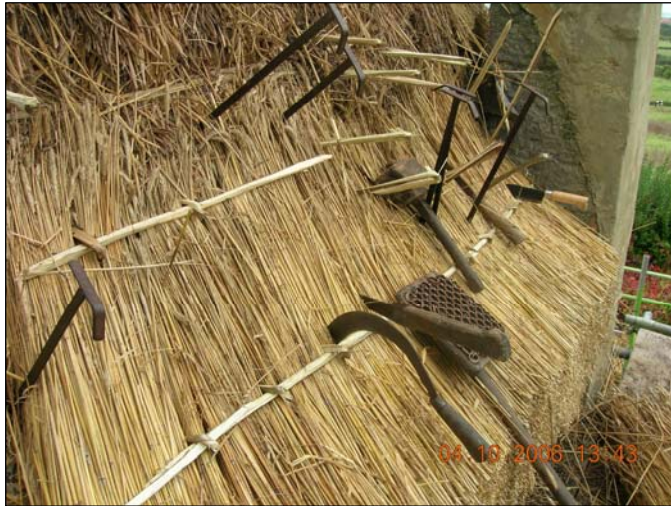
Photo 4 - Close up of combed wheat being laid. The provision of a horizontal bond formed of hazel liggers (which will eventually be concealed – see Diagram 1) highlights a major difference to laying in the Long Straw style. It should be noted however that the bond in most historic buildings within the District is formed by tying a small portion of each bundle to its neighbour – a straw bond.

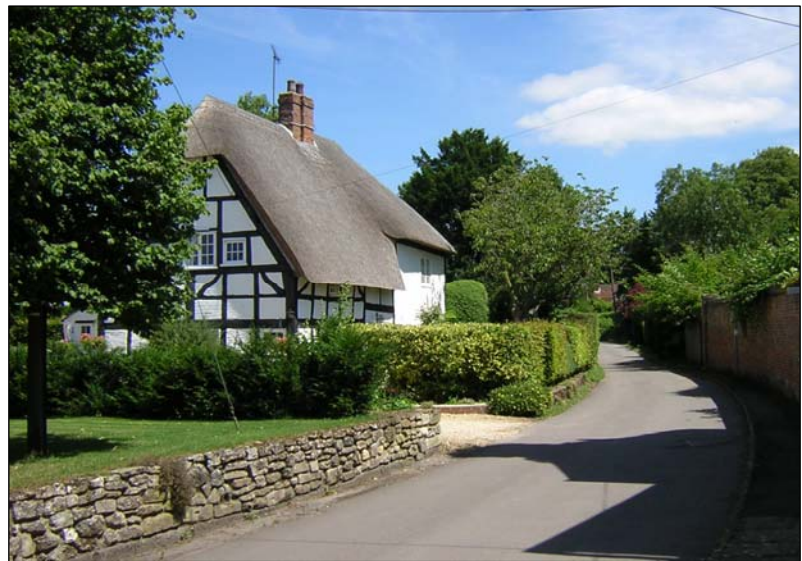
Photo 5 - a roof with a weathering coat of combed wheat – note the crisper lines and denser appearance of the thatch

Occasionally *combed wheat* is decorated to imitate the appearance of *long straw* but this should be avoided as the spars fixing the eaves rodding will tend to open-up the surface and increase the chance of rain penetrating the coat.

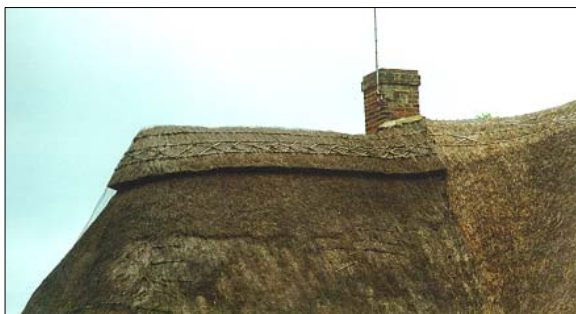
Photograph 6 - A block cut ridge

Simple straw flush ridges are usually much more satisfactory than deep block-cut ridges which are more expensive and technically inferior. Block ridges also require extra fixings and surface strapping and produce a drip line.

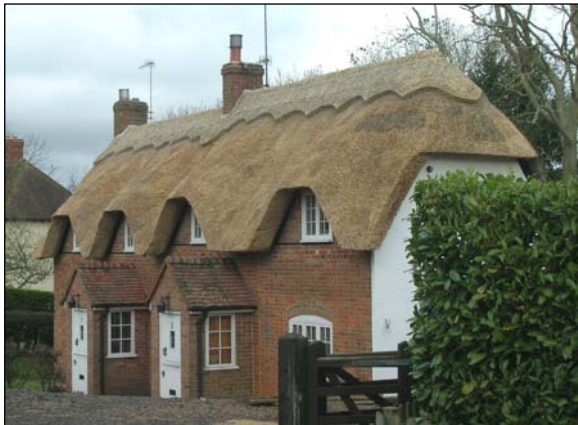
Photograph 7 - decorative block ridge

Block ridges are typical of East Anglian roofs and tend to look out of place in the Wiltshire landscape. All other things being equal, flush, wrap-over ridges (see *Diagram 1 and Photo 5*), sometimes called turn-over ridges, will prove to be the most aesthetically pleasing and more hard wearing. Butts-up ridges are more vulnerable to weathering but are sometimes justified if only one slope of the roof is being re-thatched. Accordingly the Council has adopted the following policy.

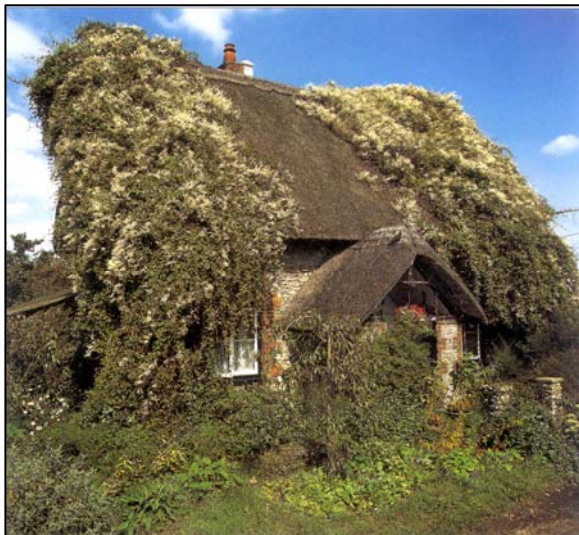
Photograph 8 – climbing plants need to be kept under control

Once re-thatching is completed, routine maintenance can help extend the lifetime of new thatch and particular attention should be given to occasional upkeep around any valleys and to the ridge. Look out for corroded wire netting and birds or vermin nesting in the roof, and climbing plants. These items should be inspected every year with an anticipated need for remedial works every ten years or so. If the netting is required to be temporarily lifted, the opportunity can be taken to gently clean off any build-up of thick mosses. In addition, external factors such as overhanging trees may need attention occasionally. The longevity of thatch can also be prolonged if all access onto the roof, for such items as fixing of tv aerials and soil vent pipes, is very carefully managed. Care should also be taken to ensure that any plastic coated wiring in the loft space is protected in a rodent resistant conduit to avoid the risk of shorting.

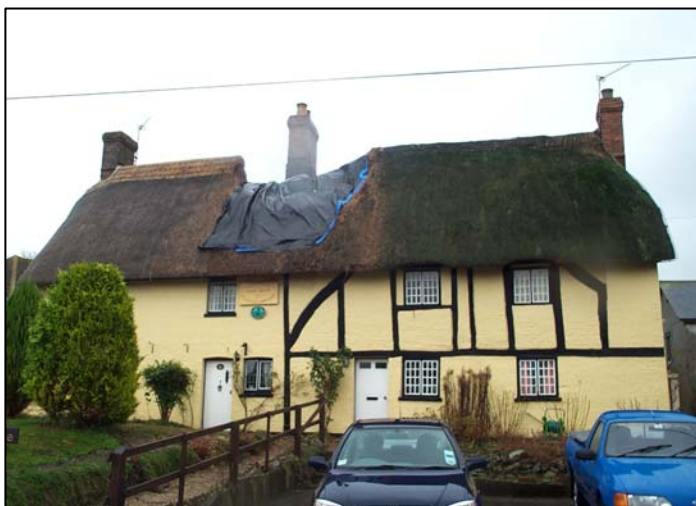
Photograph 9 – damage apparently caused due to an imperfect chimney

Although comparatively rare, fire represents one of the greatest threats to the conservation of an historic thatched roof. Even chimneys which appear to be in good order may have defective pointing or cracks below the ridge which allow hot gases to escape from the flue into the thatch. The leakage of hot gases creates hot zones which in time may combust and cause a thatch fire.

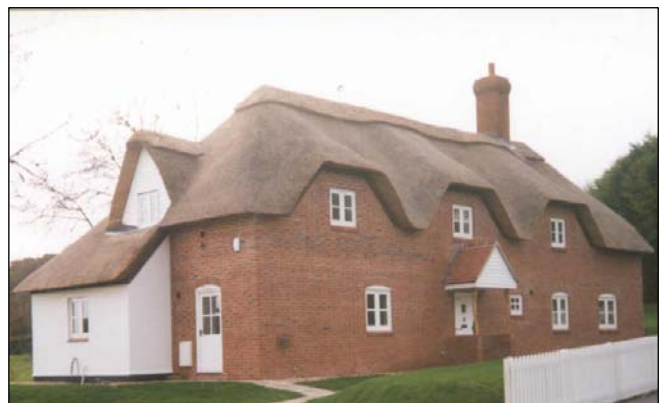
Photograph 11. Uncharacteristic features :

- ***abnormally tall chimney***
- ***dominant block ridge***
- ***gable dormer on hip end***
- ***brickwork over and around dormer windows***
- ***a high proportion of the roof lying at a shallow pitch.***

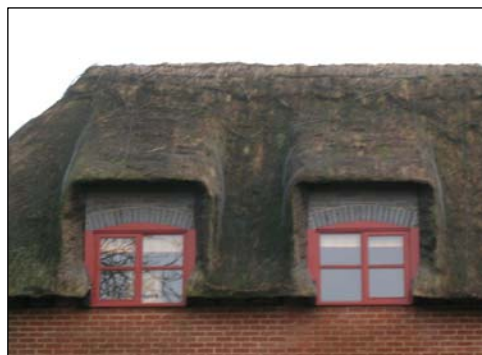
Photographs 12 and 13. Narrow valleys, higher thatch draining onto lower thatch, anomalous vertical thatch panels over and on the cheeks of tall eye brow windows.

- The creation of narrow valleys and large or gabled dormer windows should be avoided.
- The materials should continue the established tradition of using wheat straw - laid in the *long straw* or *combed wheat* methods.
